**ELECTRONICS COORDINATING OF**  
**SHIP PREPARATION**  
**and**  
**TARGET INSPECTION**

**FINAL REPORT**  
**TESTS ABLE AND BAKER**

**VOLUME 2**  
**PHOTOGRAPHIC RECORD**

**DIRECTOR OF SHIP MATERIAL**  
**JOINT TASK FORCE ONE**  
**OPERATION CROSSROADS**

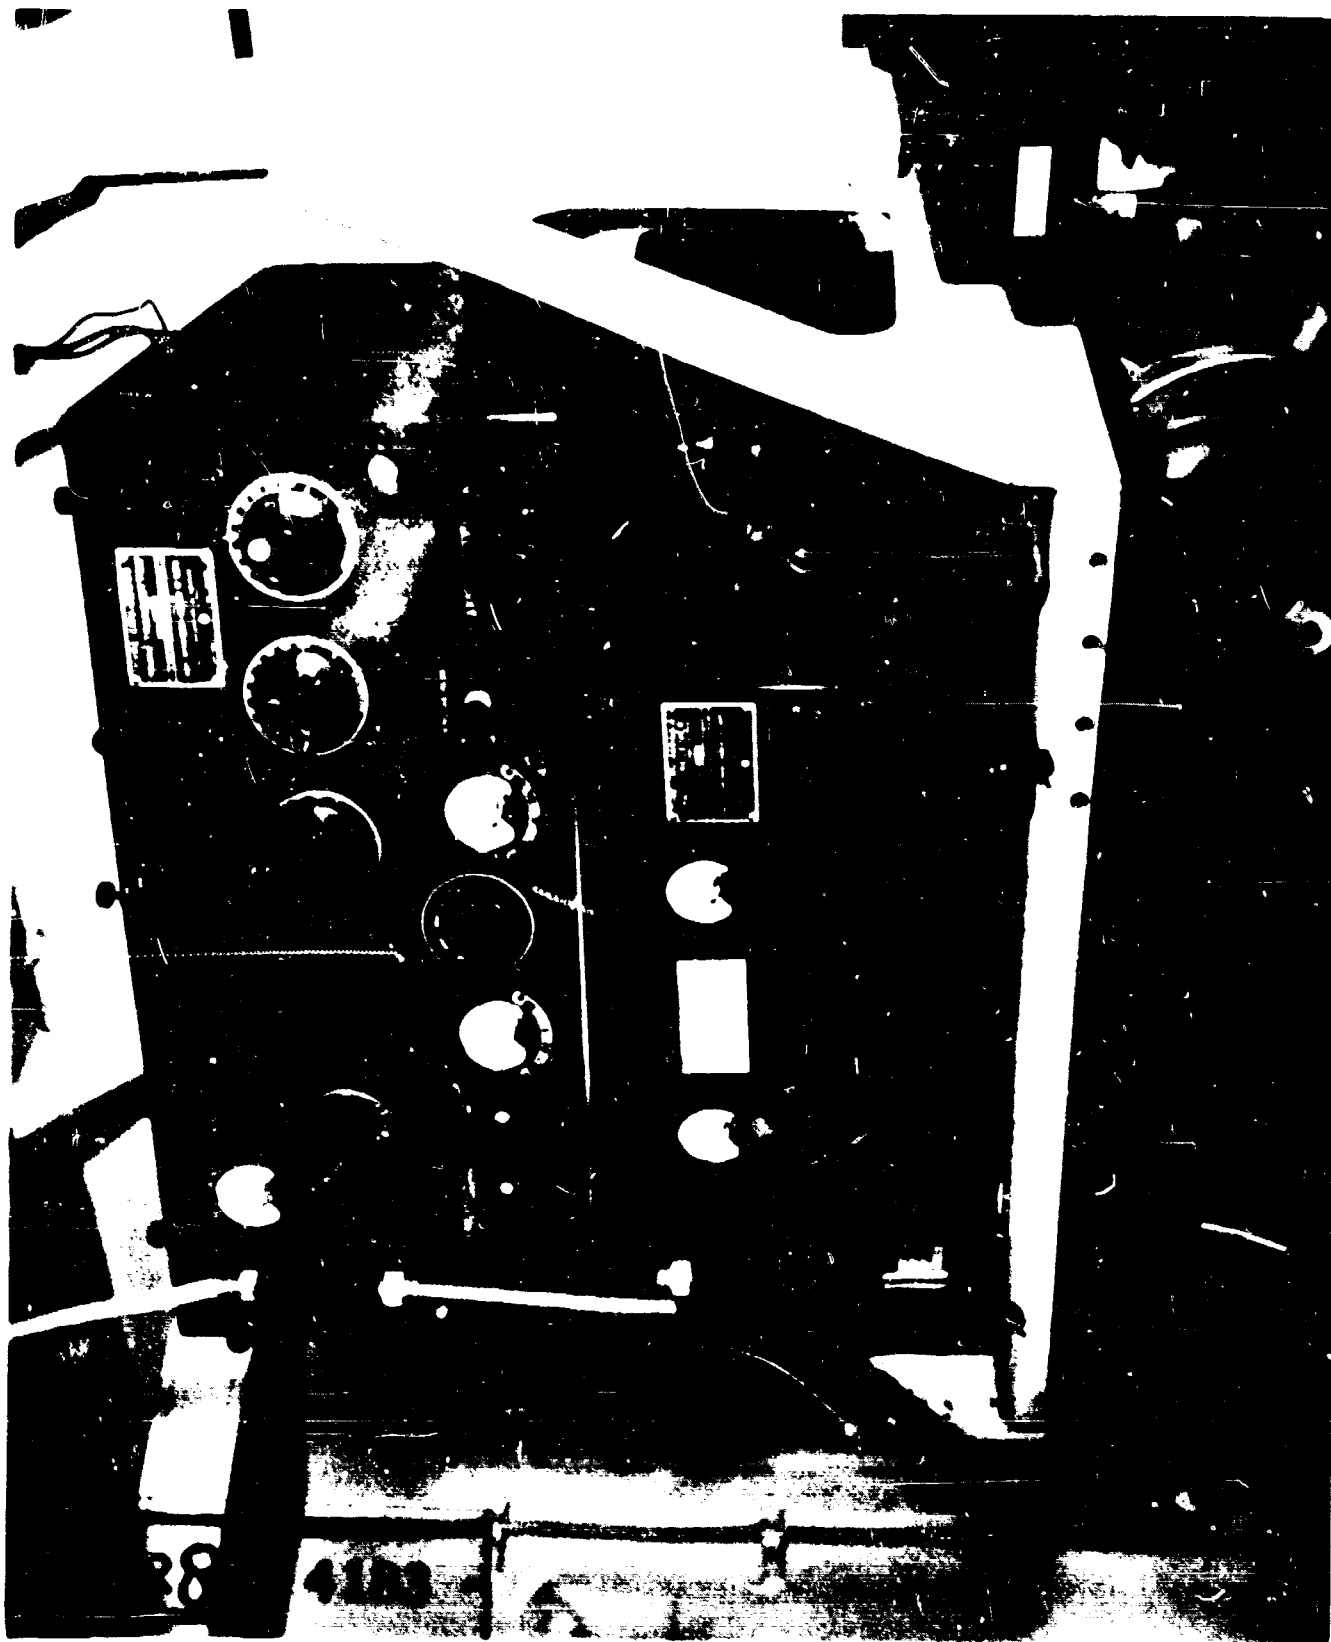
U.S.S. FALLON (APA 81)  
#569

POST BAKER - RADIO I. Violence of shock sheared mounting bolts between receiver and transmitter on TBS-6, resulting in damage to receiver transmission line.

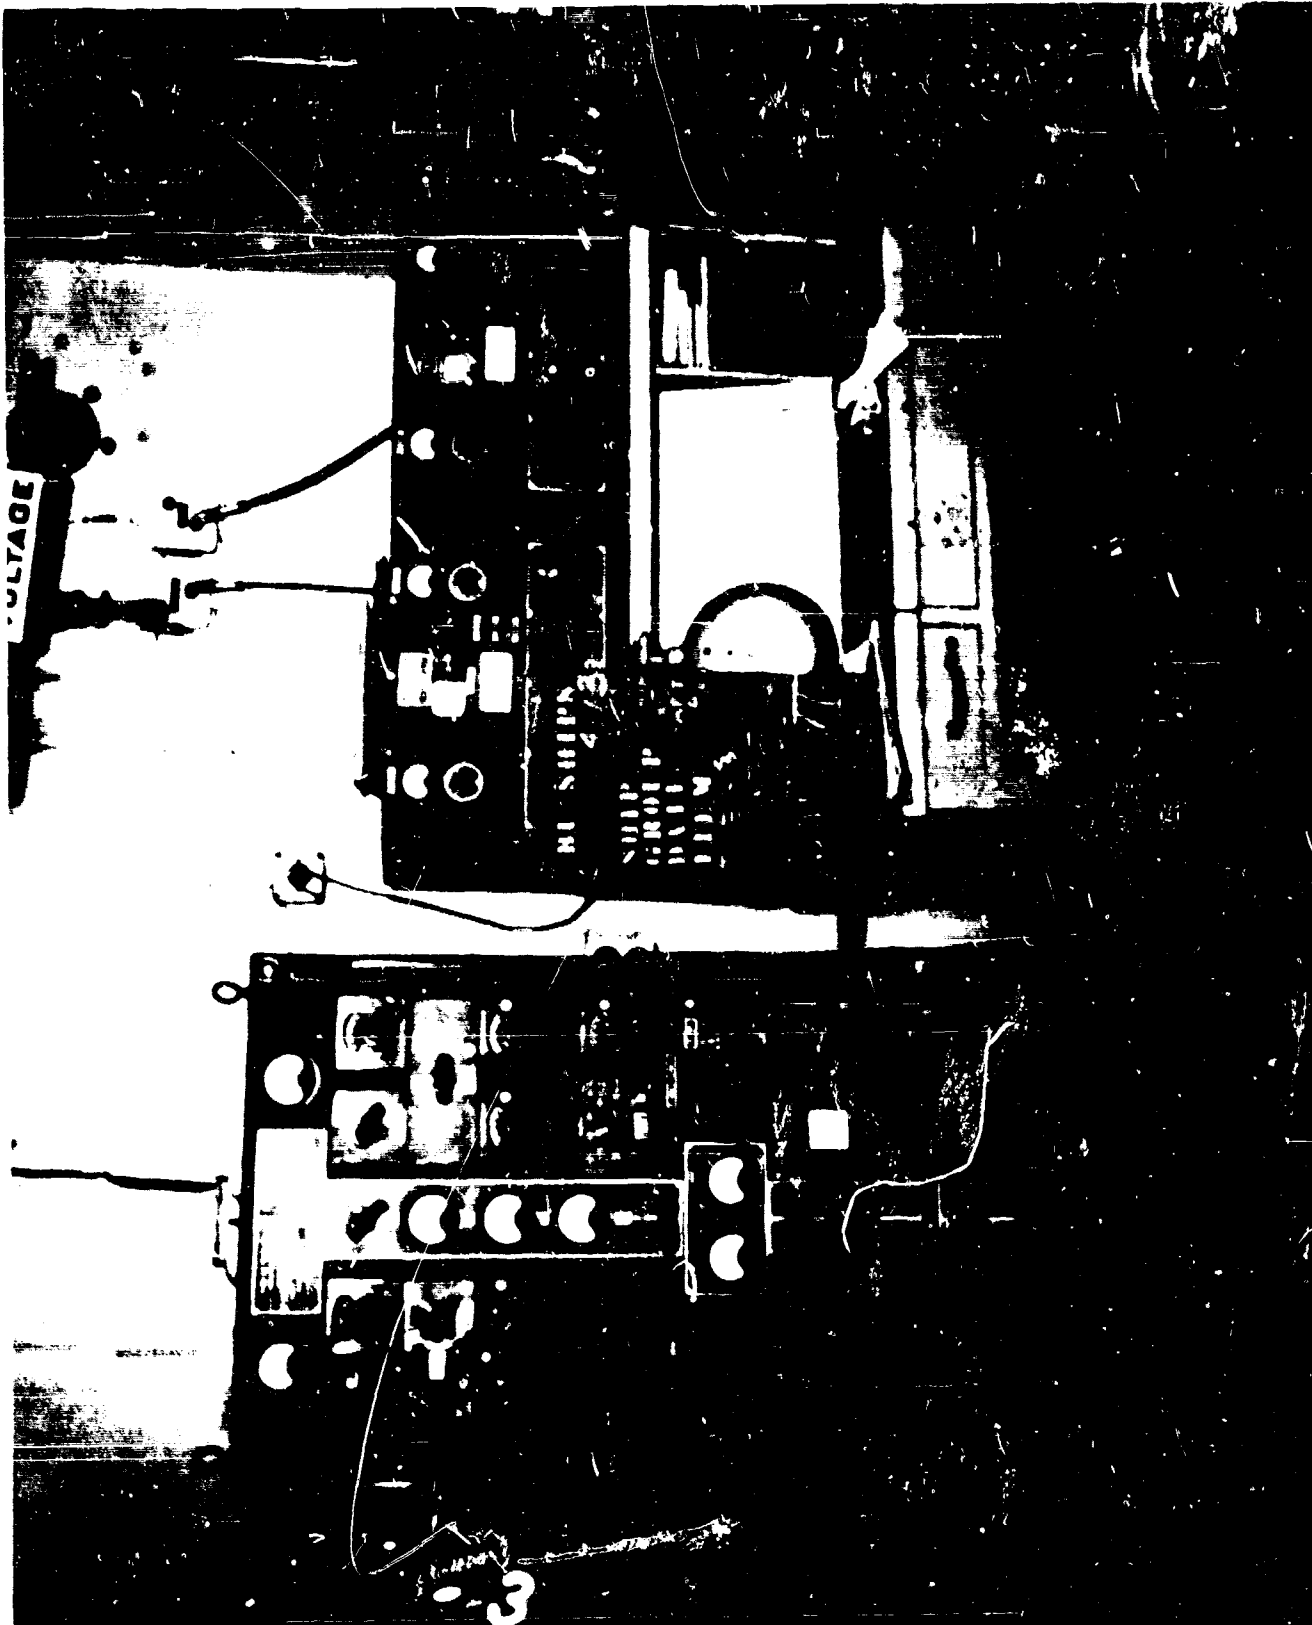
PRE BAKER - RACIA II. Shows TDR-3 and RAK/RAL. This equipment was undamaged during Test Able.

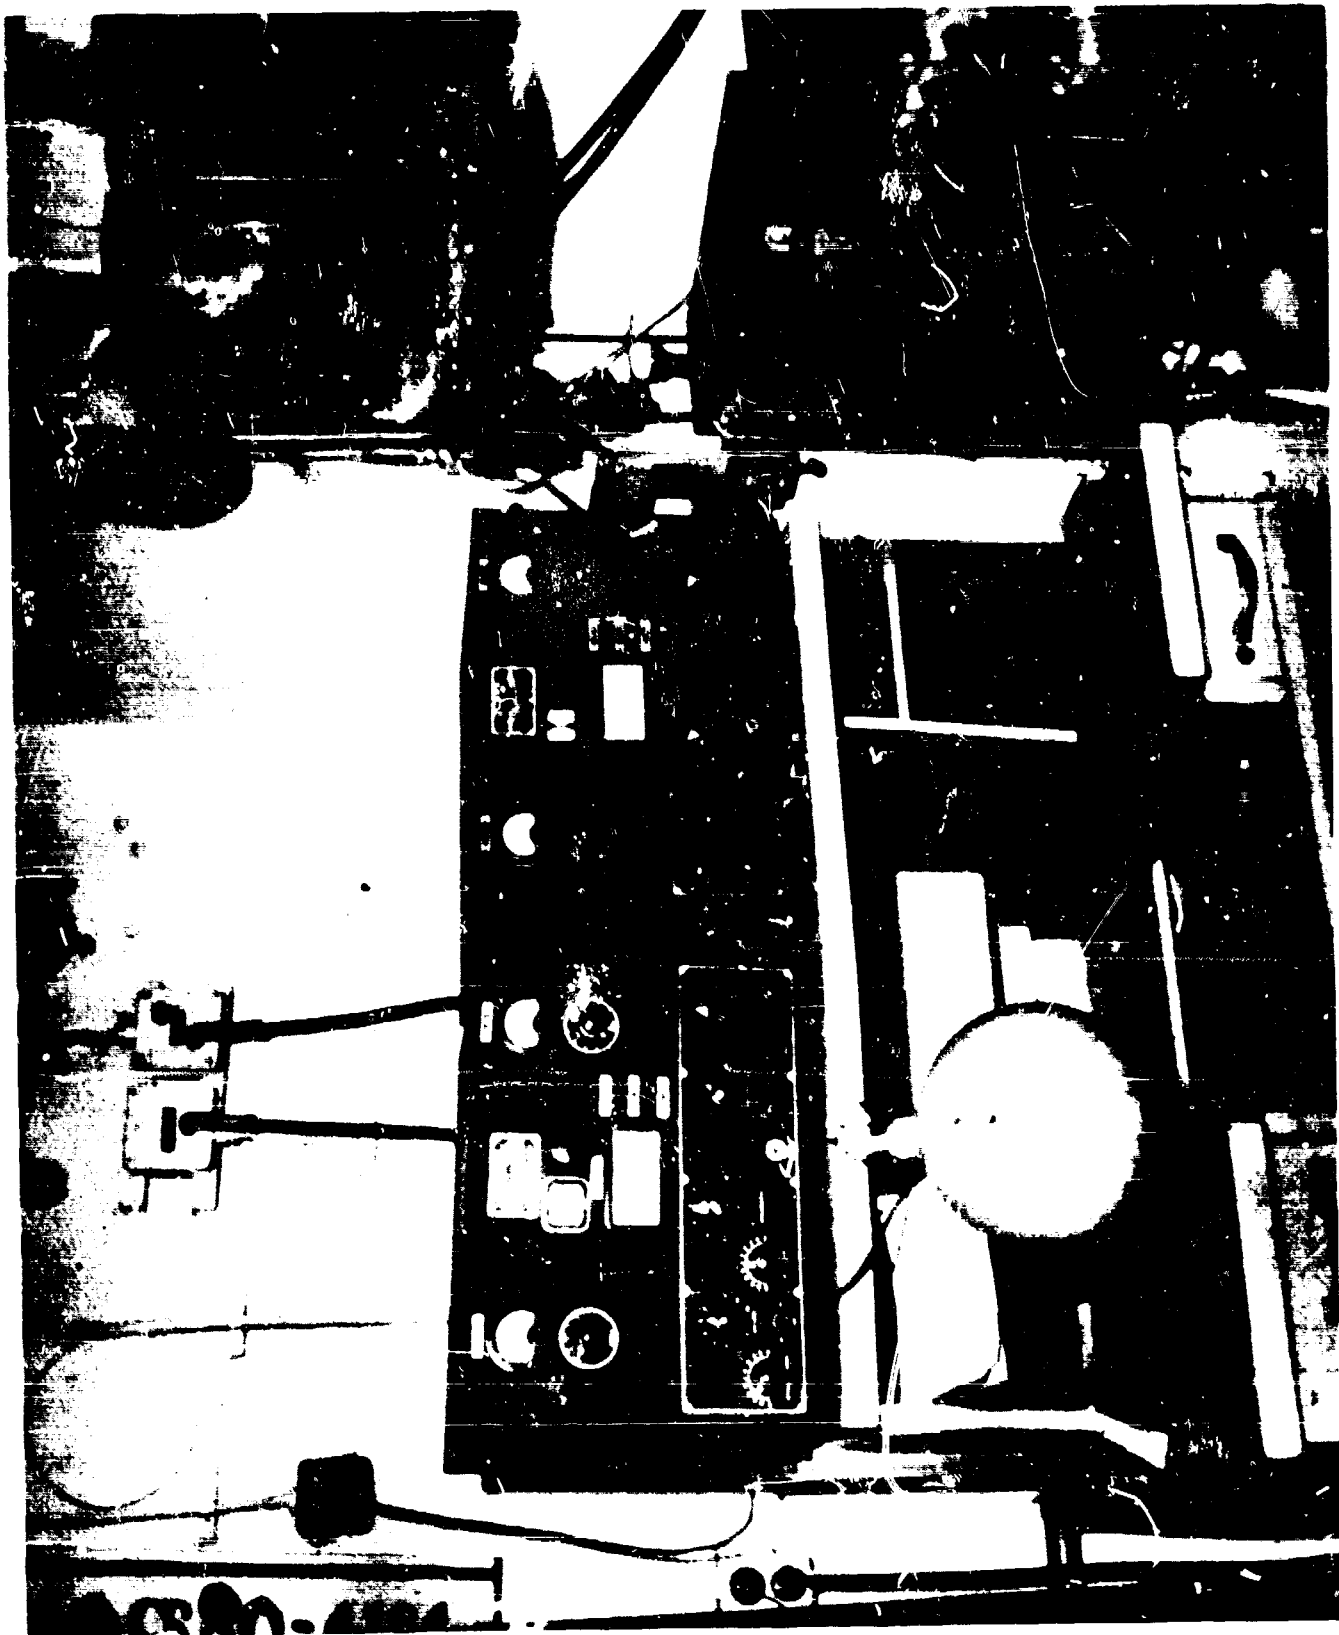
U.S.S. FALLON (APA 81)

POST BAKER - RADIO II. Operating position showing twisted desk. At extreme lower edge of picture is the empty power supply cabinet from which power supply was thrown to deck.

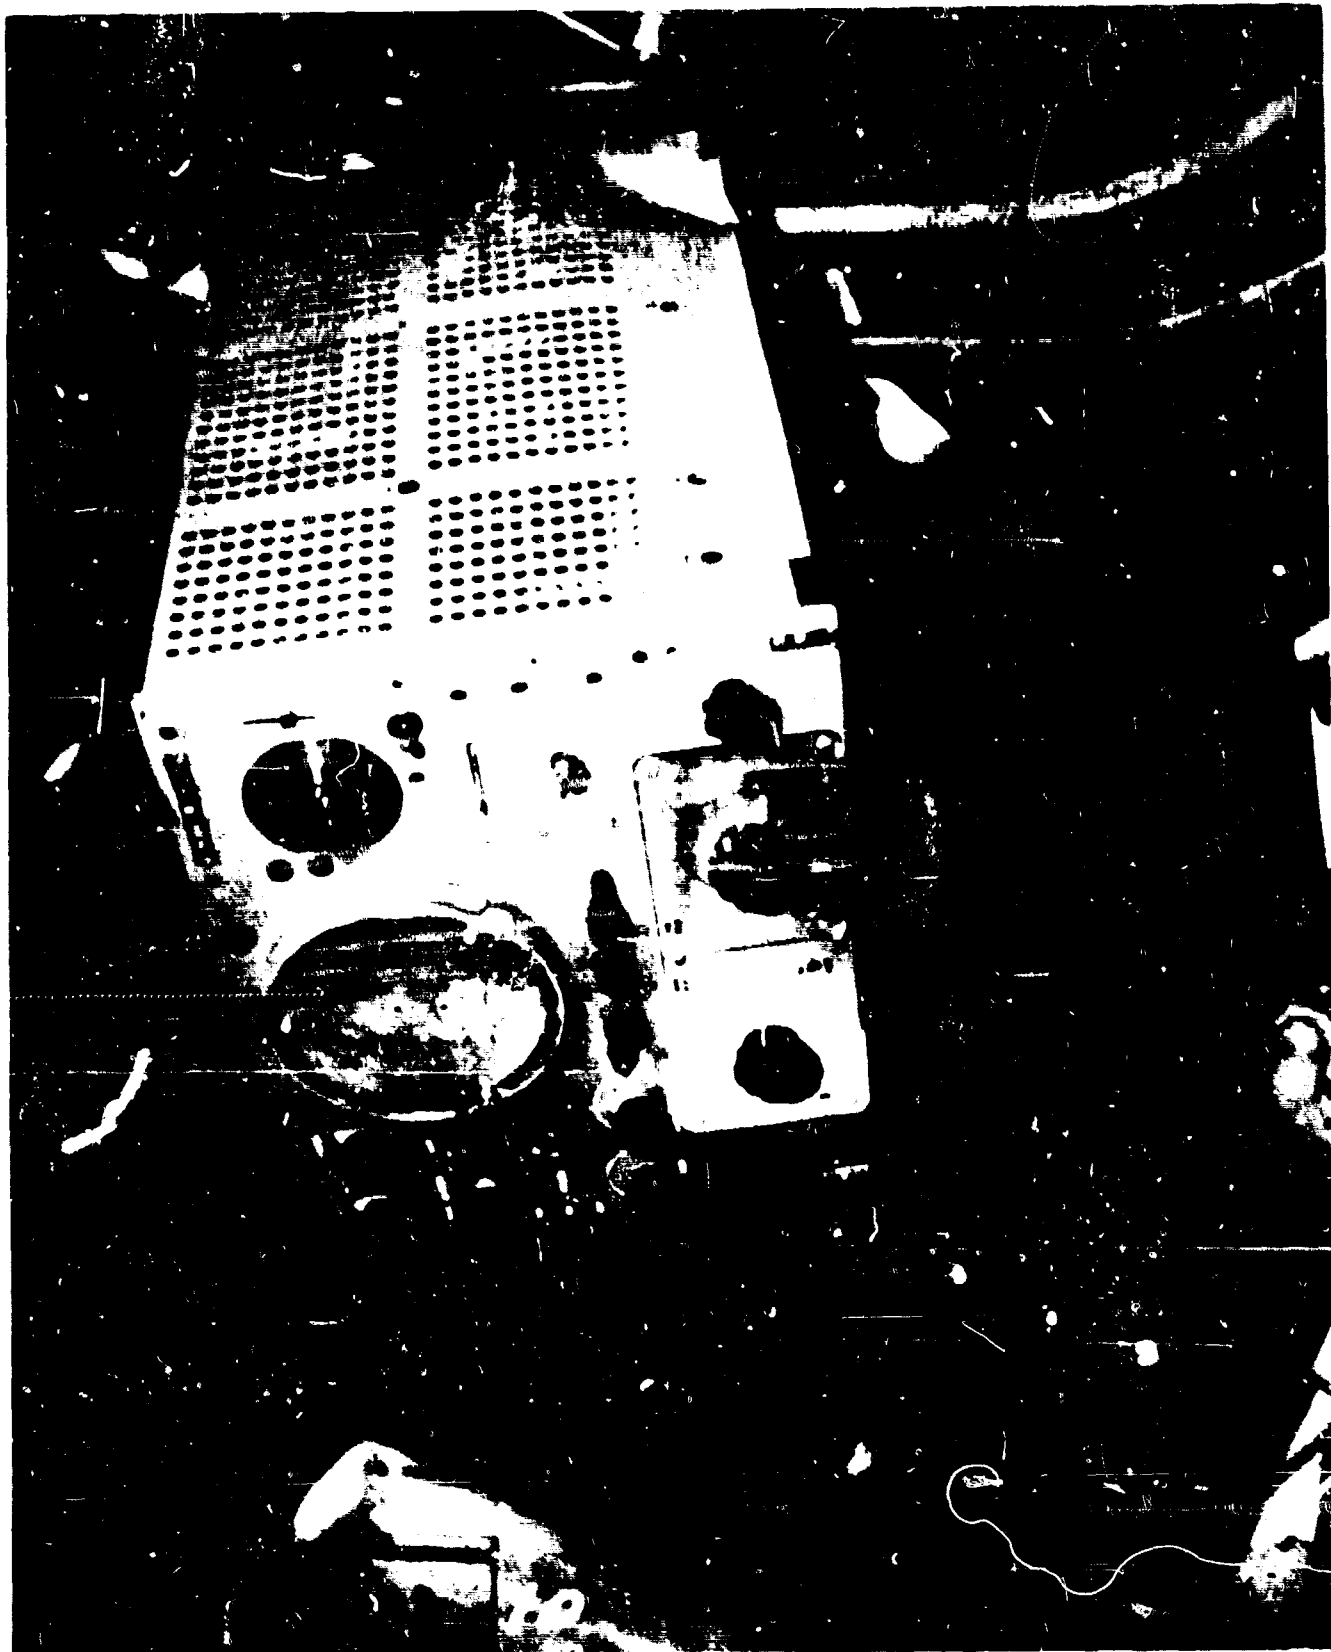
U.S.S. FALLON (APA 81)

POST BAKER - DAS-3 IN CIC. The aircraft type mounting failed and indicator was jammed between vent and plotting table.

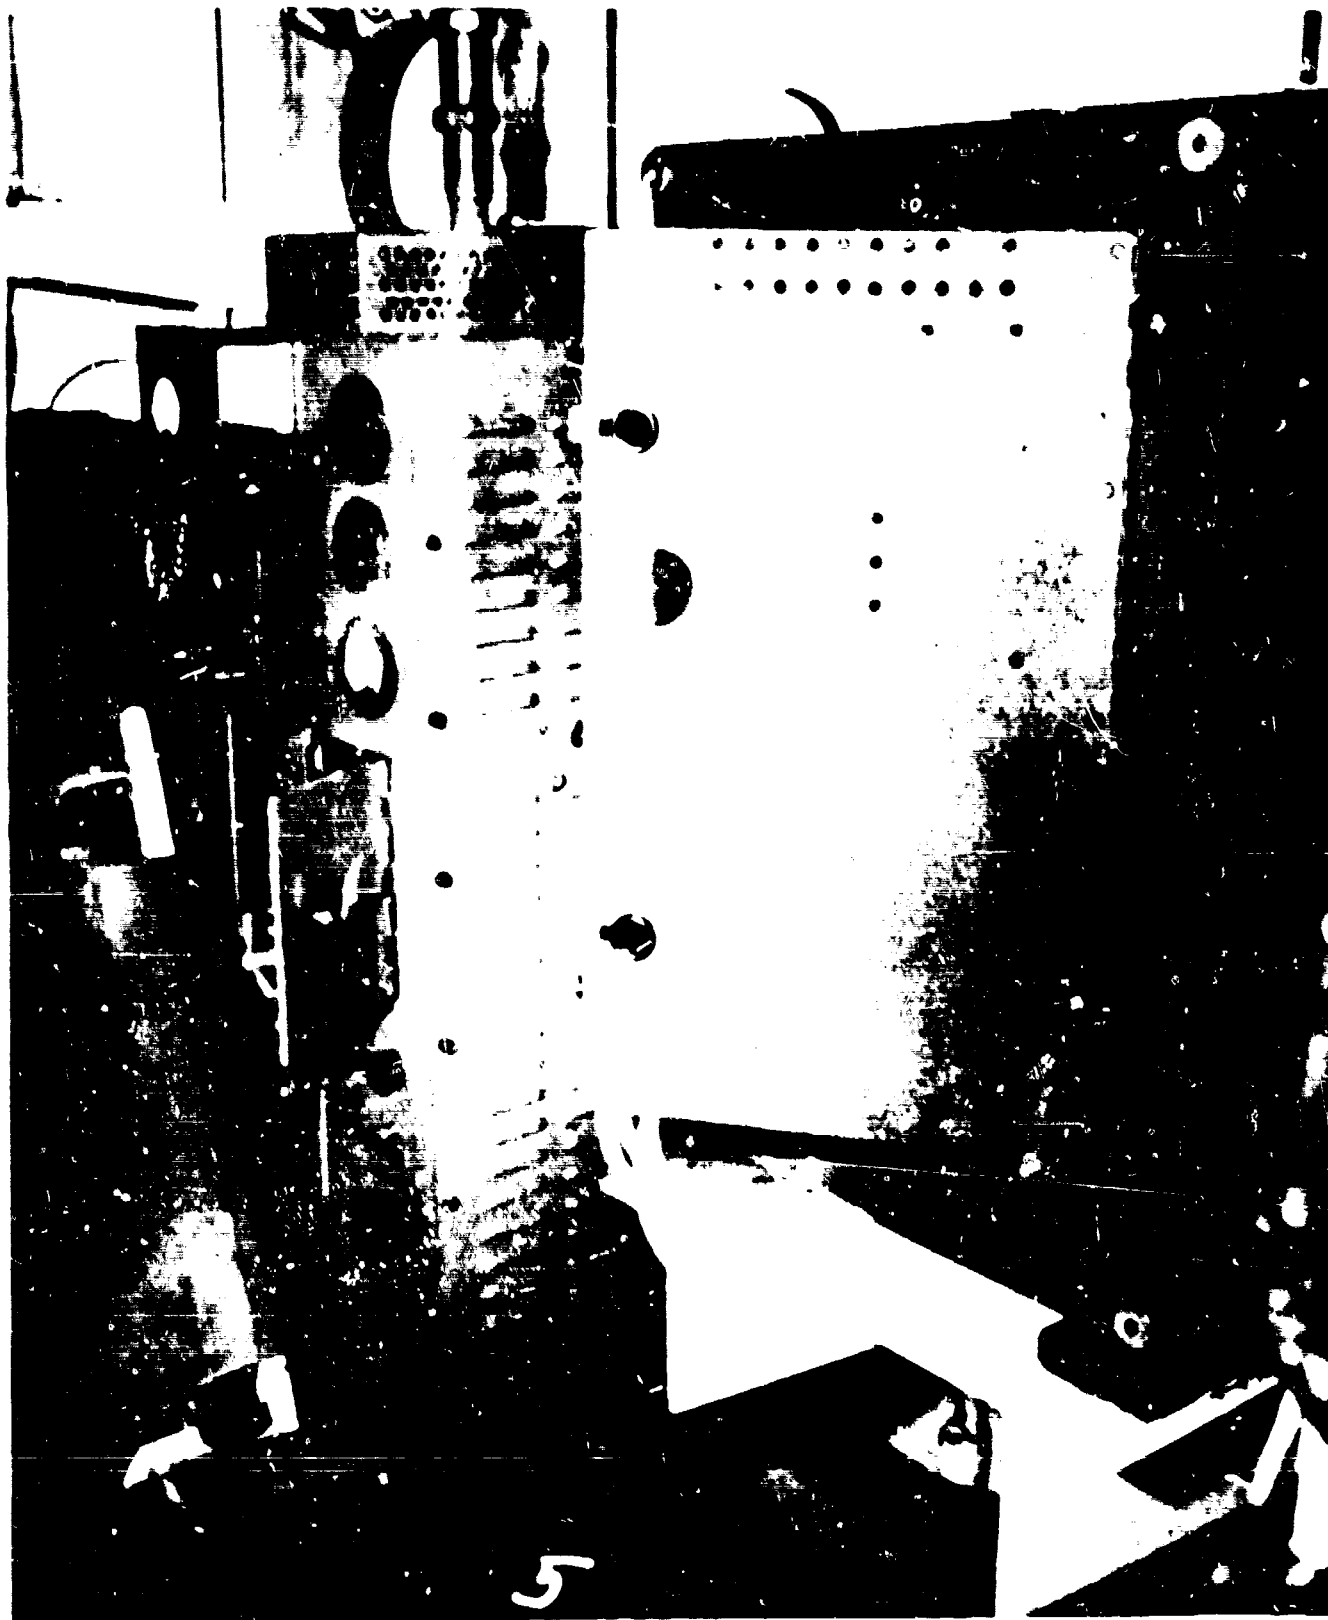
FIG. 1. RADIO-1. The 30 ring oscillator tubes (4 327's)  
were broken. FM-1 is in foreground.

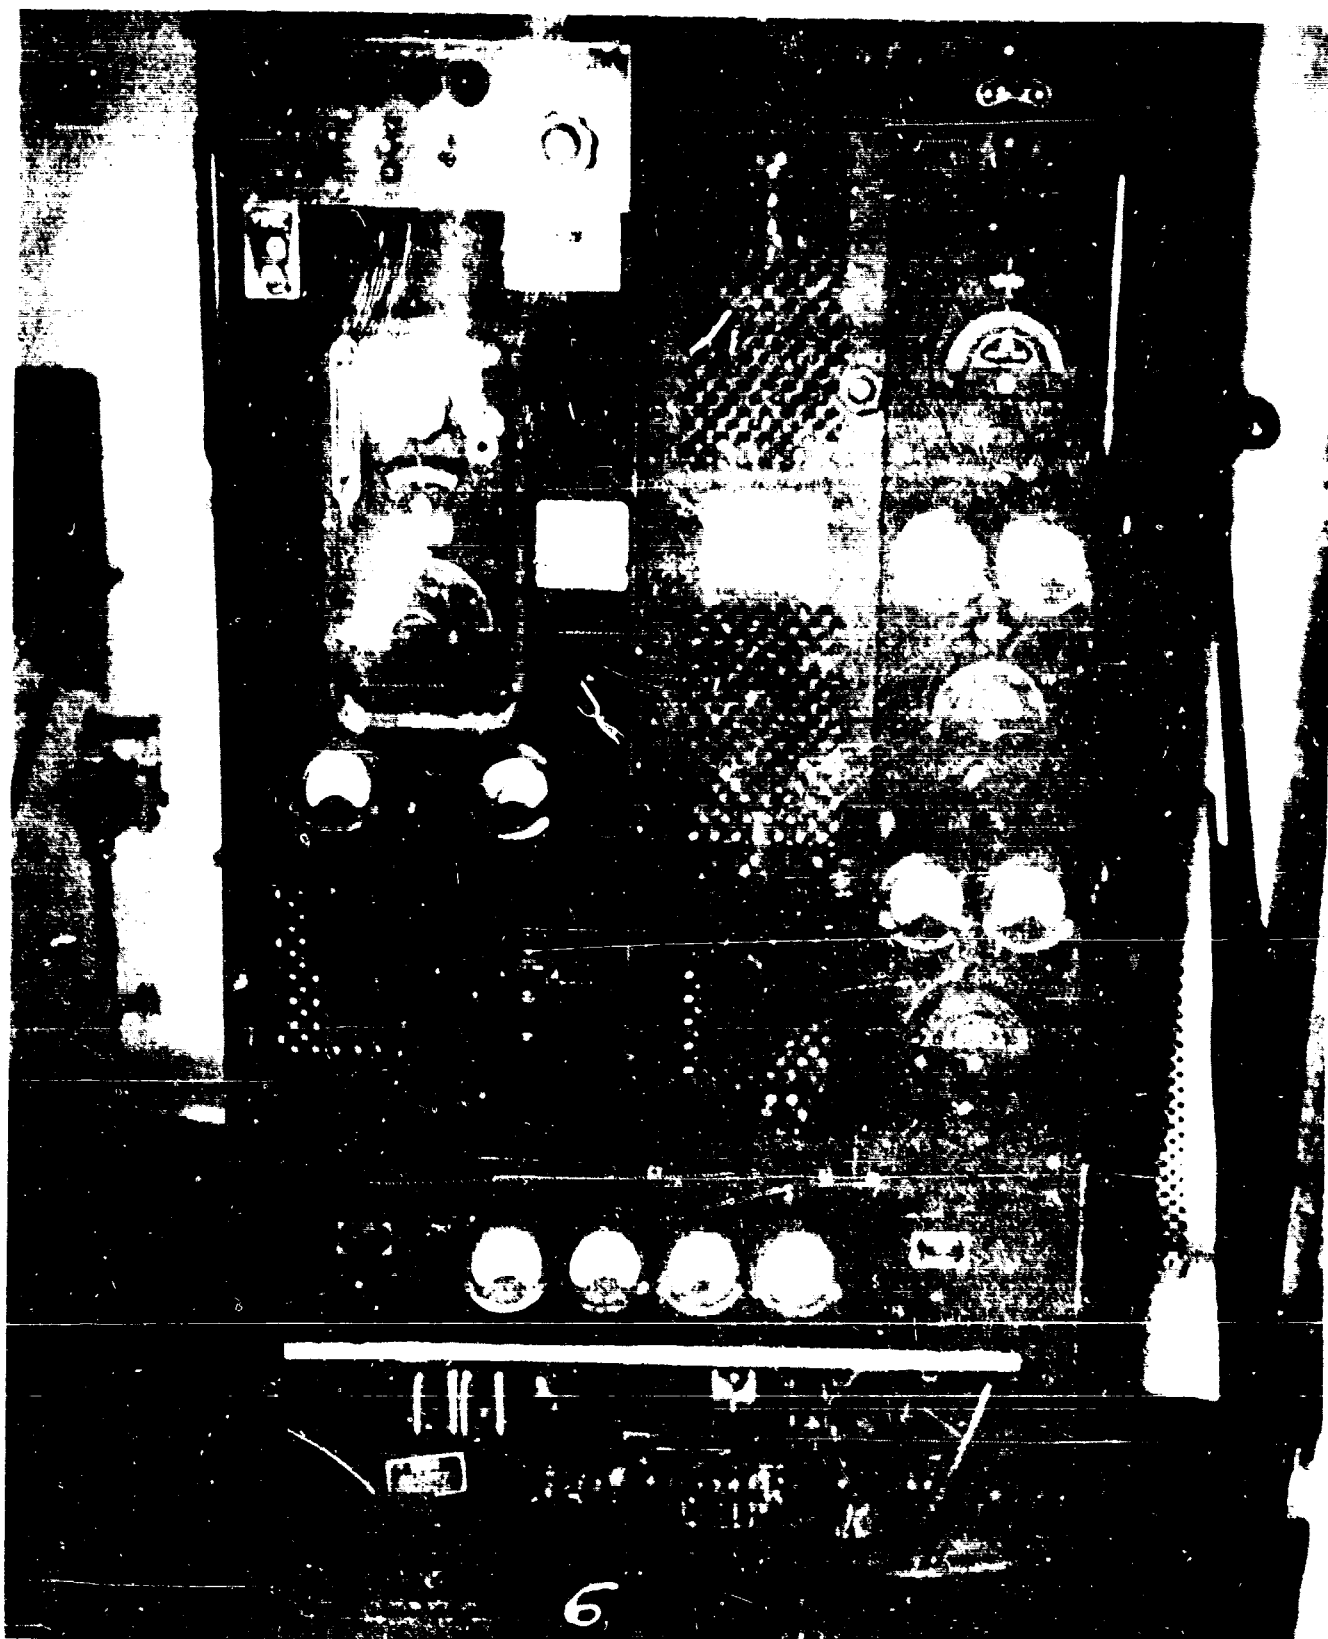
U.S.S. GASCONADE (APA 85)  
Page 272 of 274 pages

POST BAKER - TBM-13 IN RADIO III. Initial damage due to fire was light, with two meters broken at center left of picture and lower panel open and warped, apparently by flying debris. Secondary damage, due to water splashing around on deck, rendered equipment inoperative until cleaned and dehydrated.

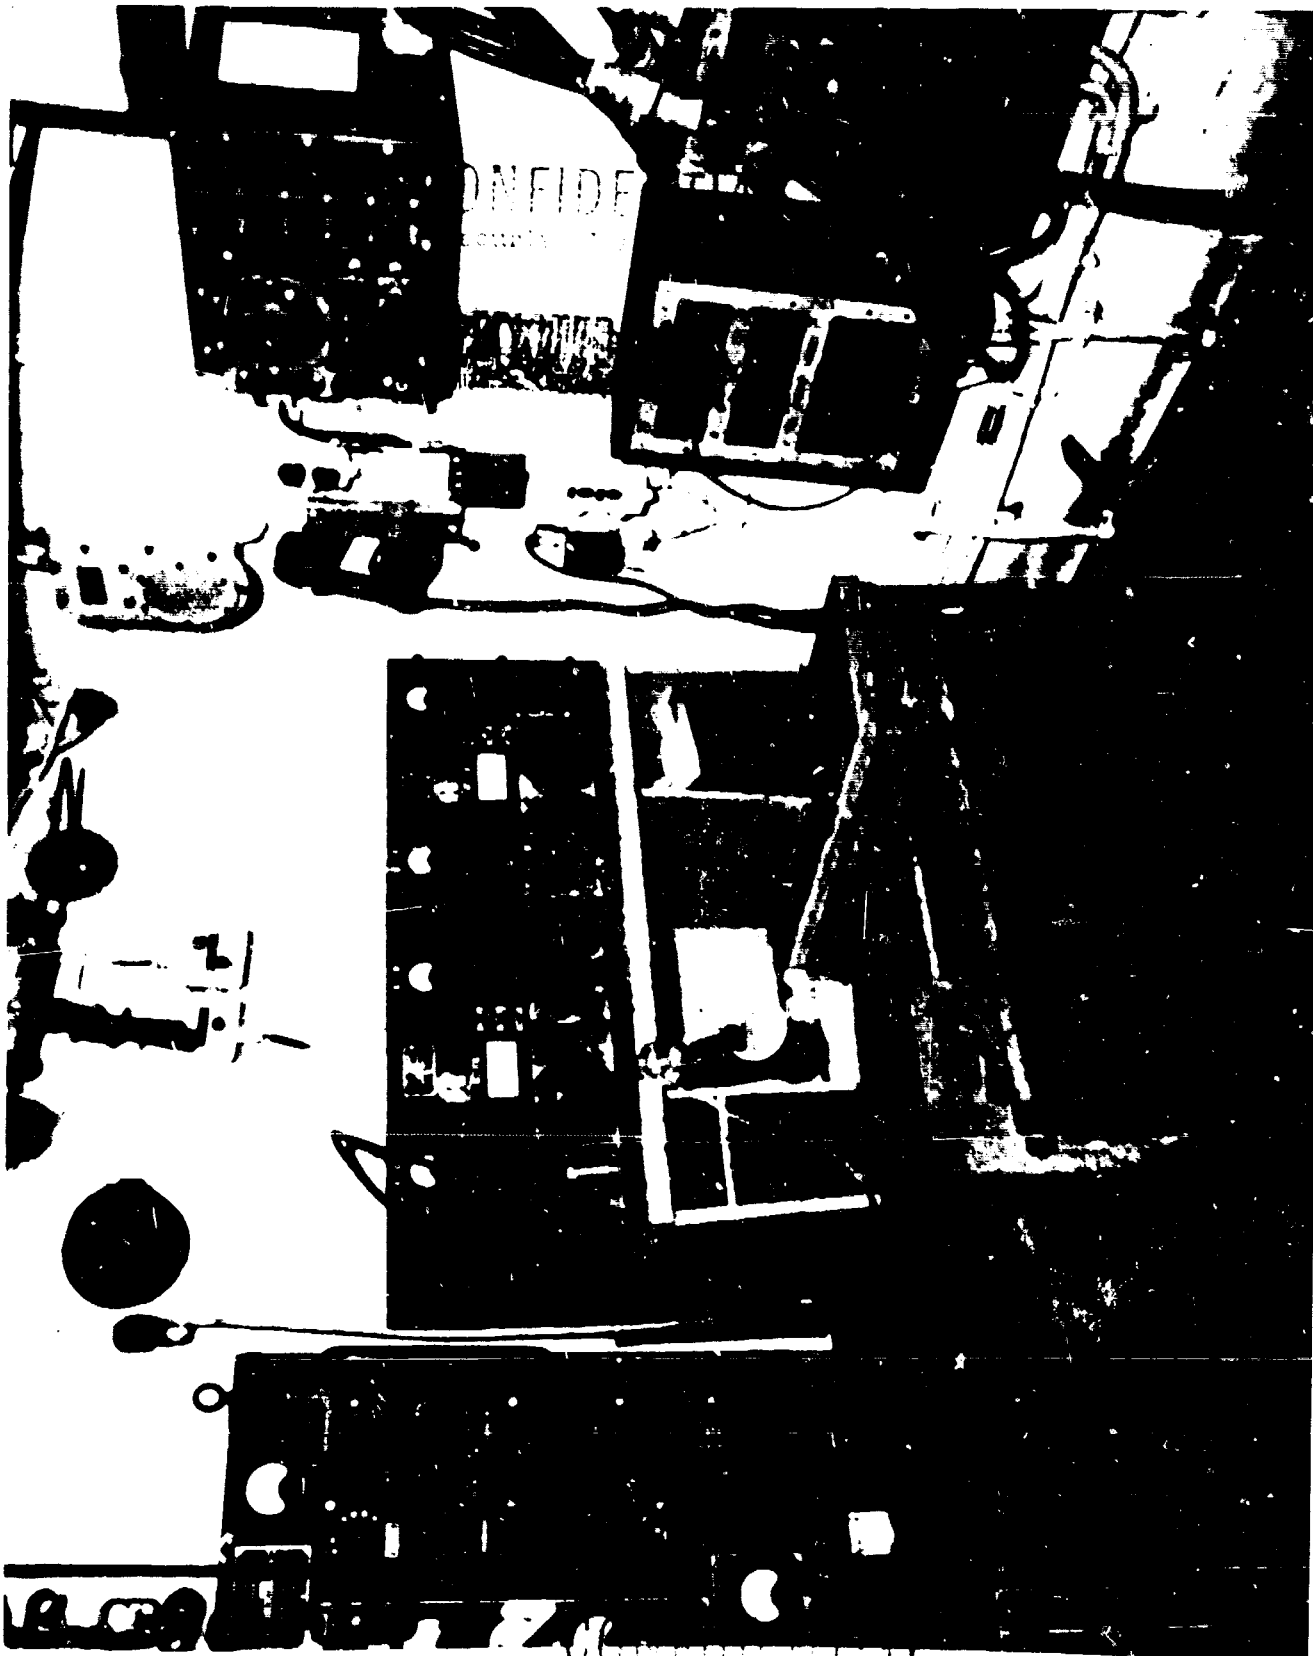
POST BAKER - RADIO III. View showing damaged desk and immersed receiver power supplies. TDE at left was rendered inoperative by immersion.
